WATERGRASS CDD I
SUMMARY REPORT: ASPHALT SEEPAGE INVESTIGATION

May 14, 2017

I. Project Background

The purpose of this report is to present a summary of special services provided to Watergrass CDD to assist with the diagnosis of an asphalt seepage issue within the community. The scope of services included monitor well installation, survey, data collection and analysis, and in drain camera scope investigation.

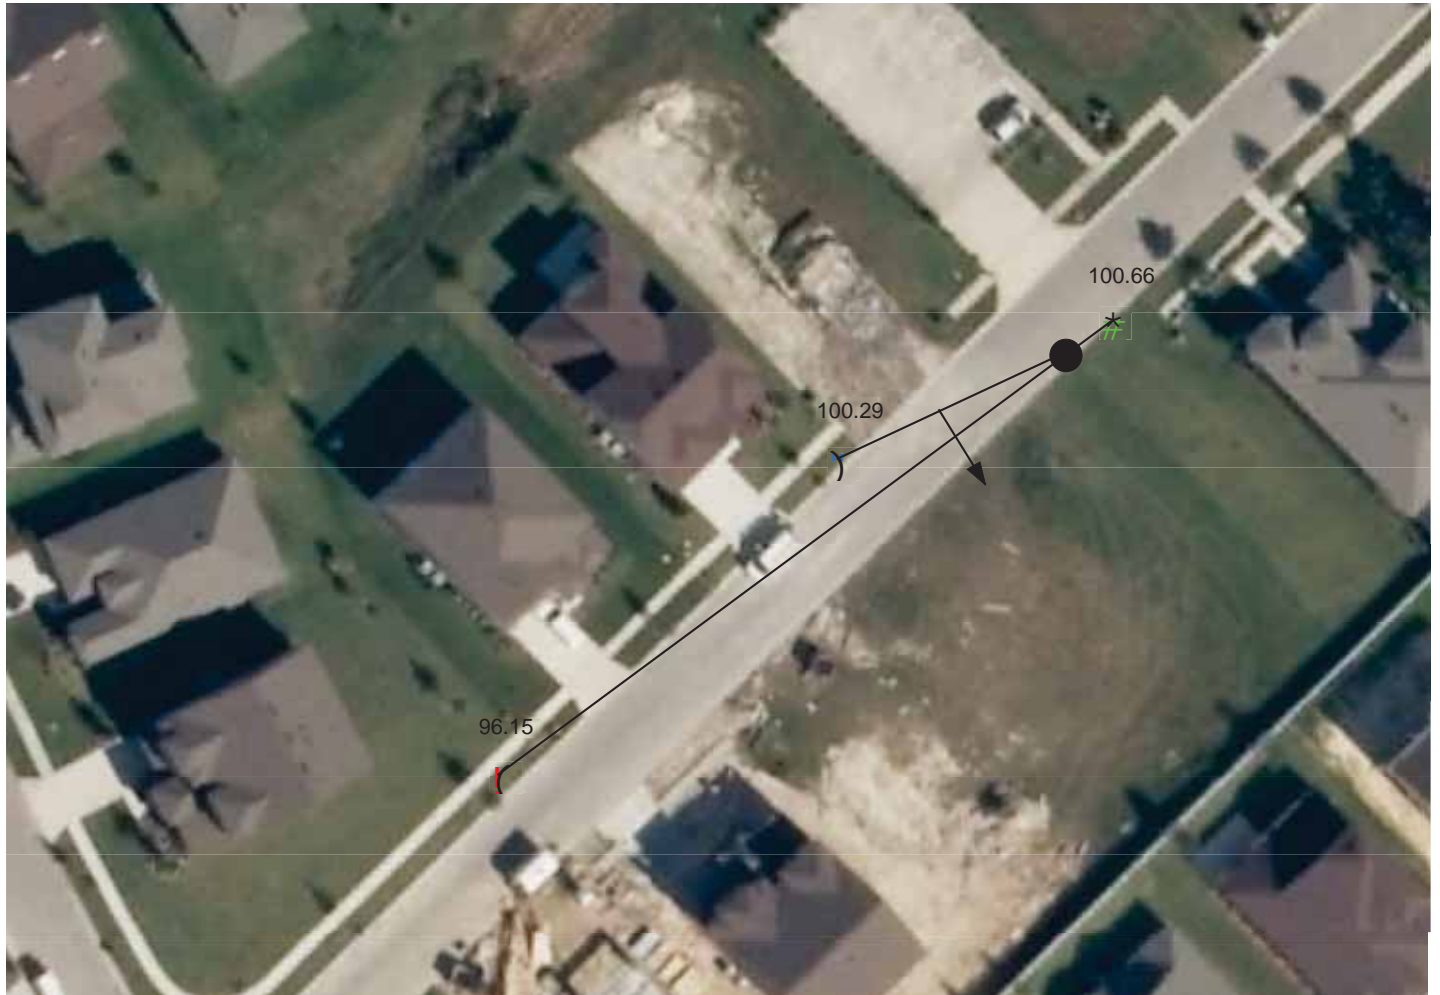
Watergrass CDD - Groundwater Flow Map

- i. The flow gradient between wells 2 and 3 was steeper than between wells 1 and 2. This could be an indication of poor soil percolation and/or some other impediment.
 - 1. Well #1: Located northeast and up gradient of the seepage area. Water level was about one (1) foot below ground elevation over the monitoring period.
 - 2. Well #2: Located at the seepage area. Water level hovered around ground elevation across monitoring period. Flow appears to be impeded in this location.
 - 3. Well #3: Located southwest and down gradient of the seepage area. Water level was about 2.5 feet below ground elevation over the monitoring period.

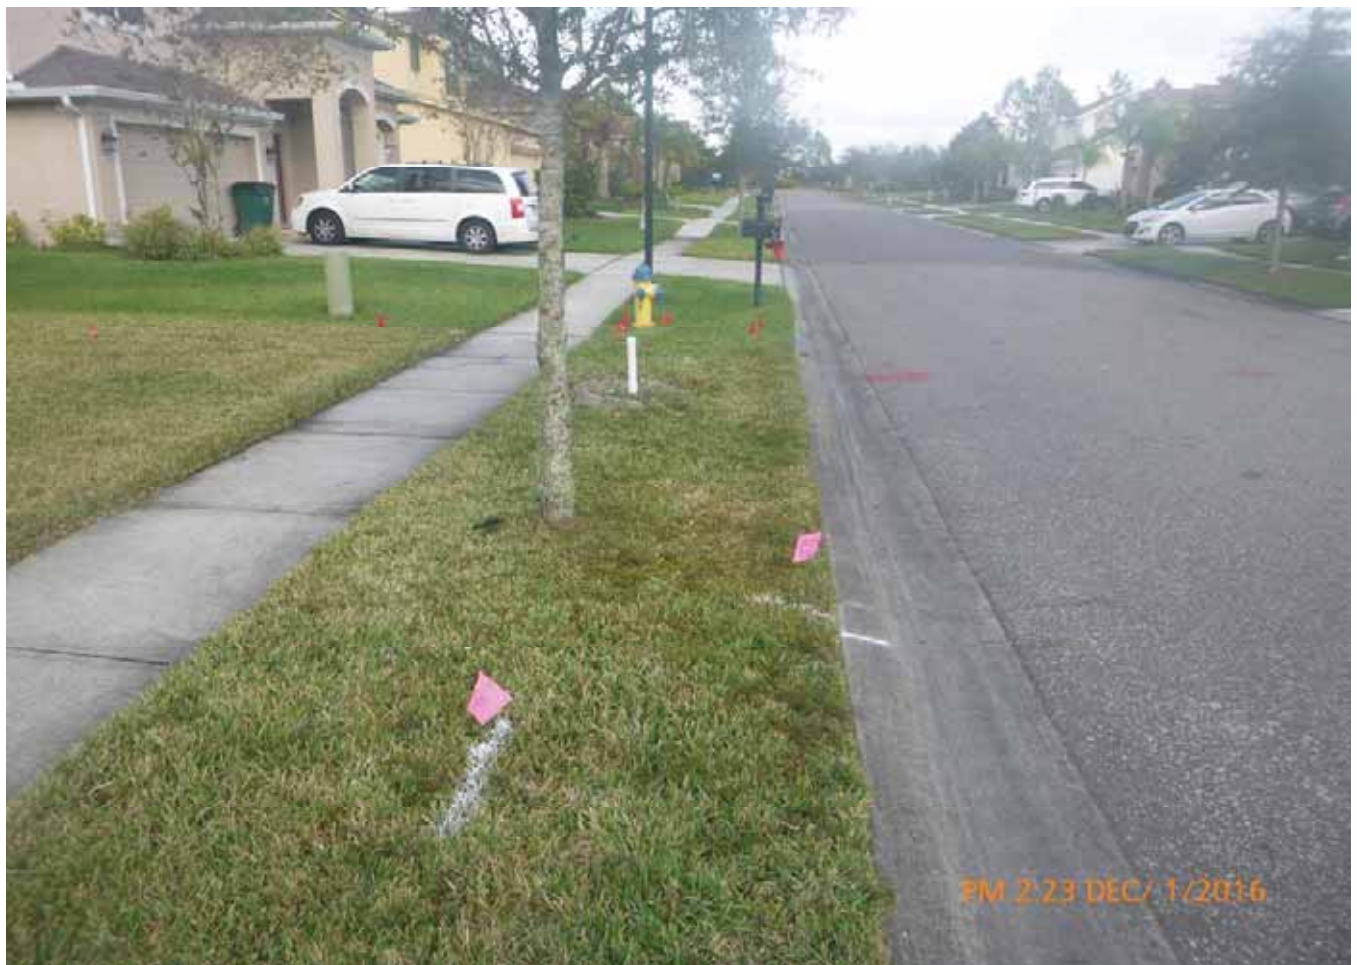
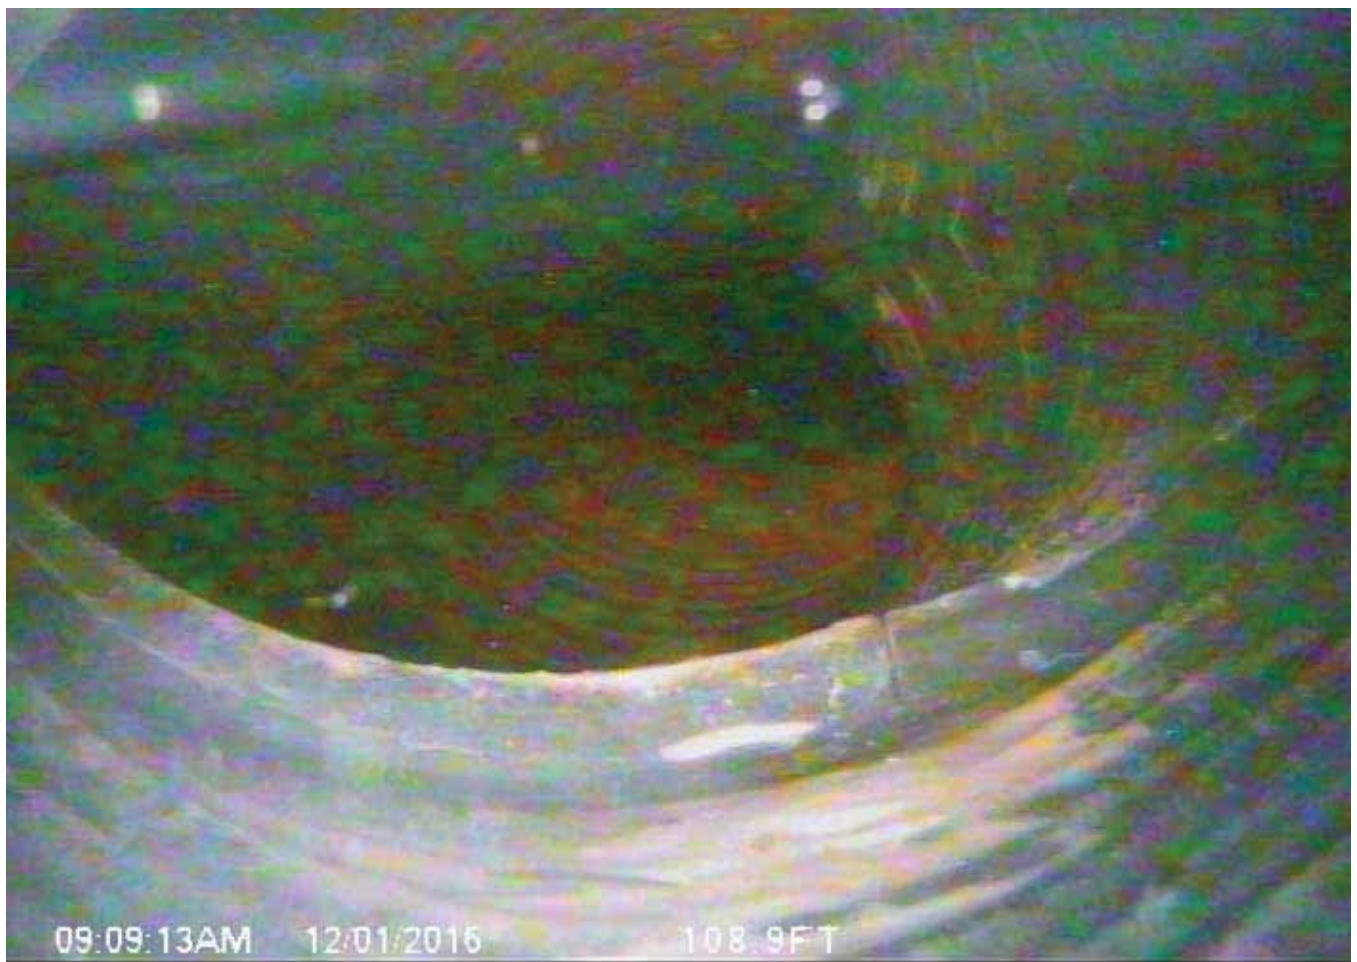
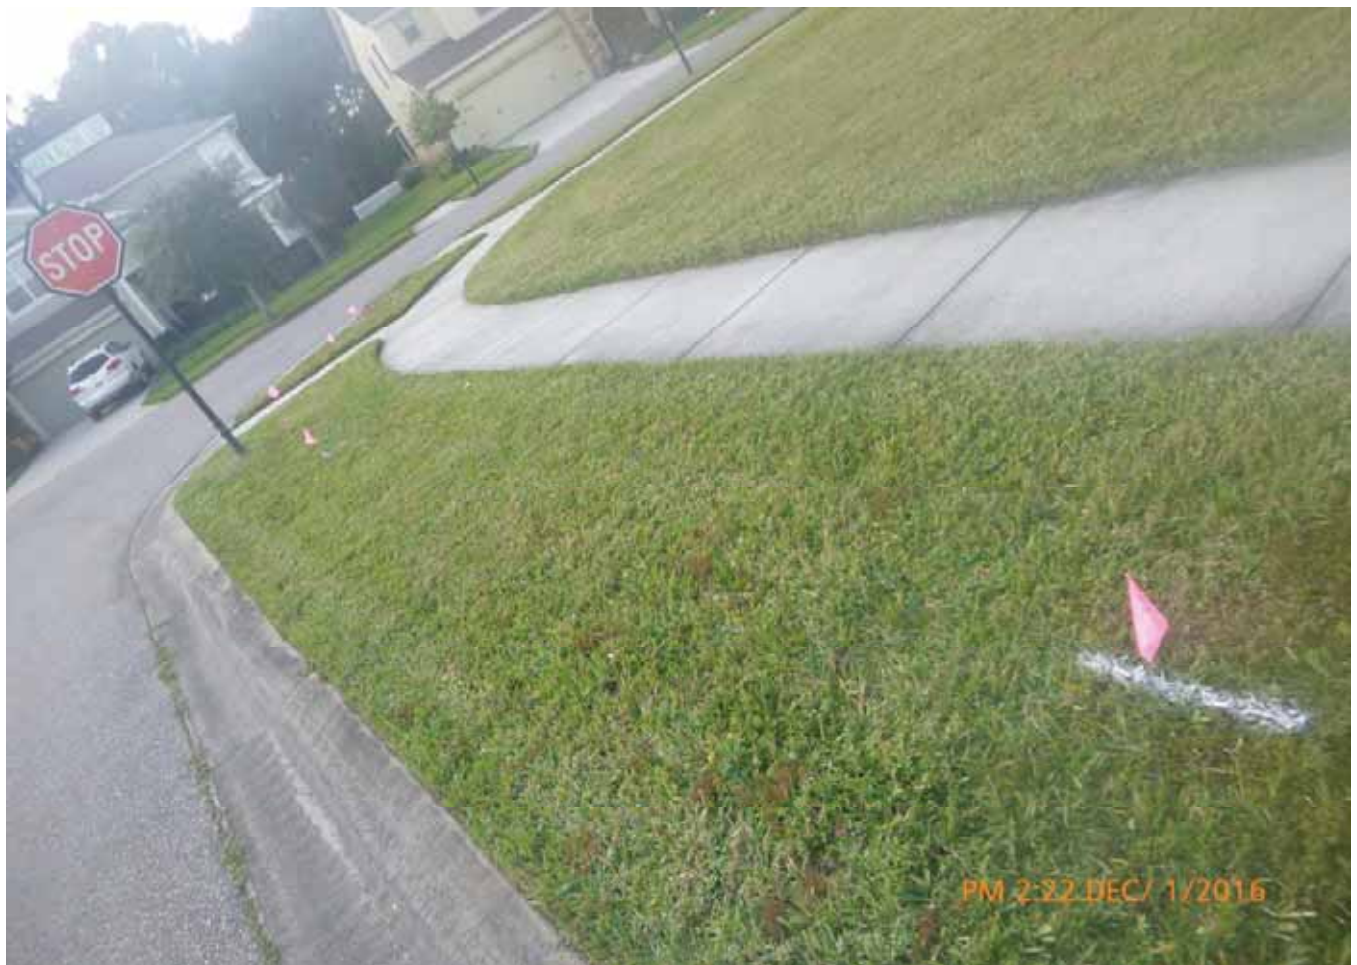
PM 2:22 DEC/ 1/2016

- i. On 12/1/16 Cardno Geospatial & Utilities performed an in-drain camera scope. Efforts were focused on the northeast side of Cottage Glen Lane. The underdrain appeared unobstructed to about 100 feet (north from the access point). Due to a potential separation in the underdrain, the camera could not proceed beyond approximately 105 feet from the point of entry.

On December 1st, 2016, Cardno investigated the underdrain piping along the western side of Cottage Glen Lane as requested through the use of a push-rod submersible camera. The underdrain was accessed at the northwest curb inlet at Garden Alcove Loop and Cottage Glen Lane. The underdrain was clear for over 100' going north from the access point. Unfortunately, due to a potential separation in the underdrain, the camera could not proceed beyond approximately 105'+/-.

Although it was not part of Cardno's scope, in an effort to provide as much information as possible, Cardno provided an alignment painted on the ground surface of the underdrain and took several photos. Please see attached.

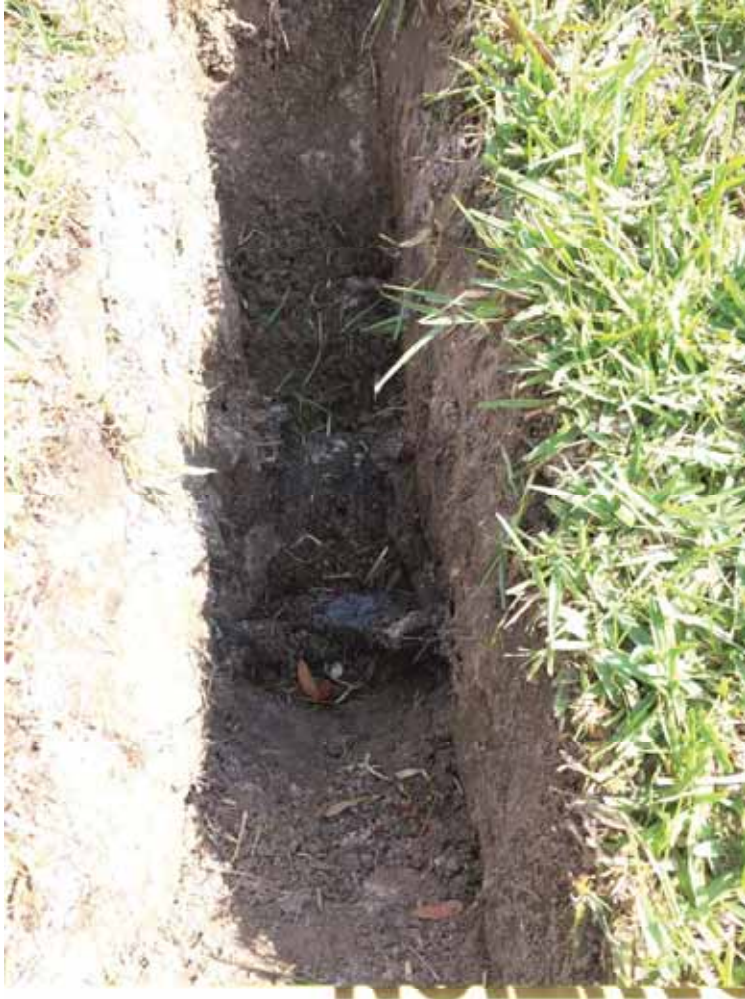
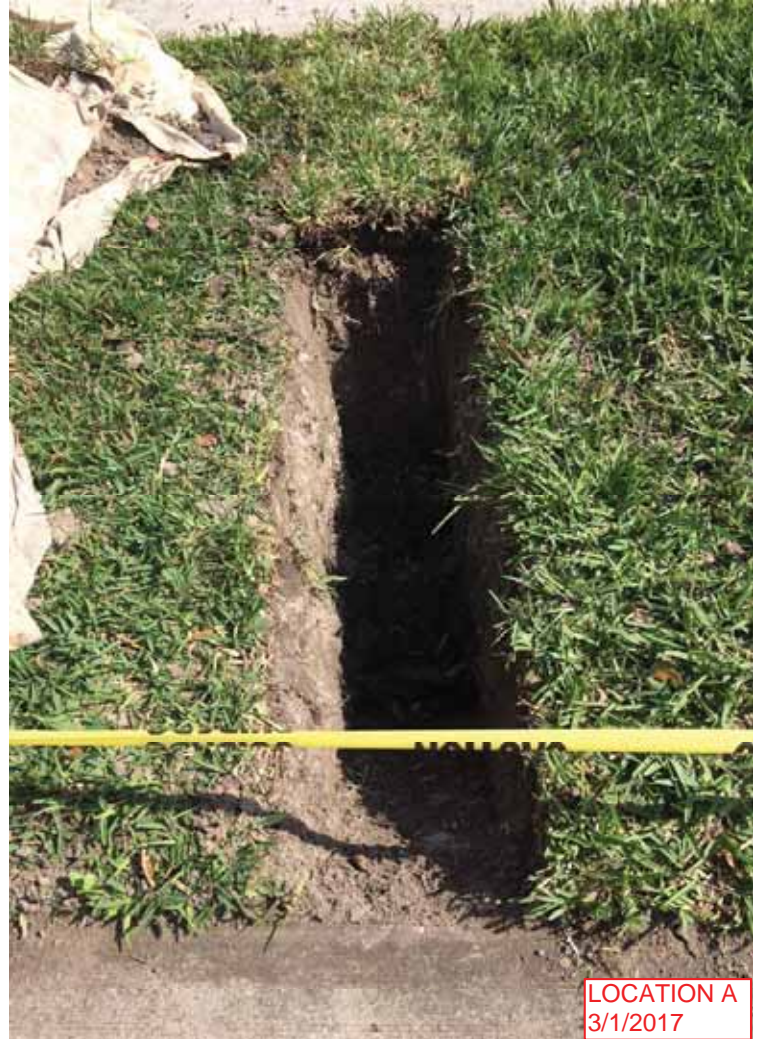
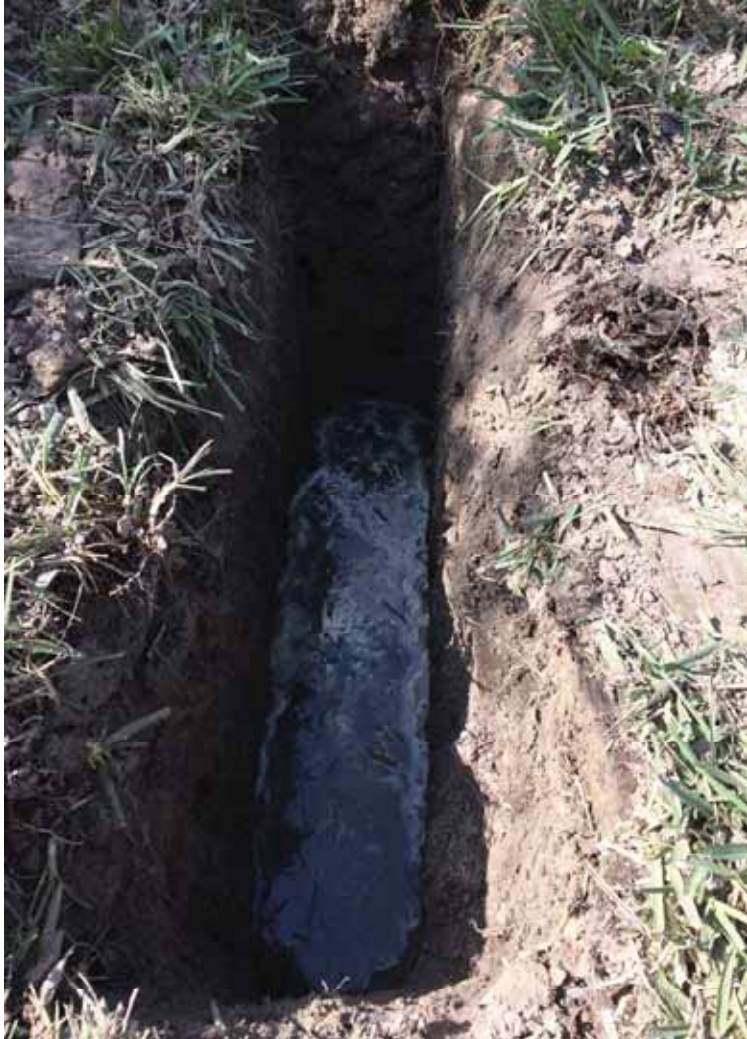
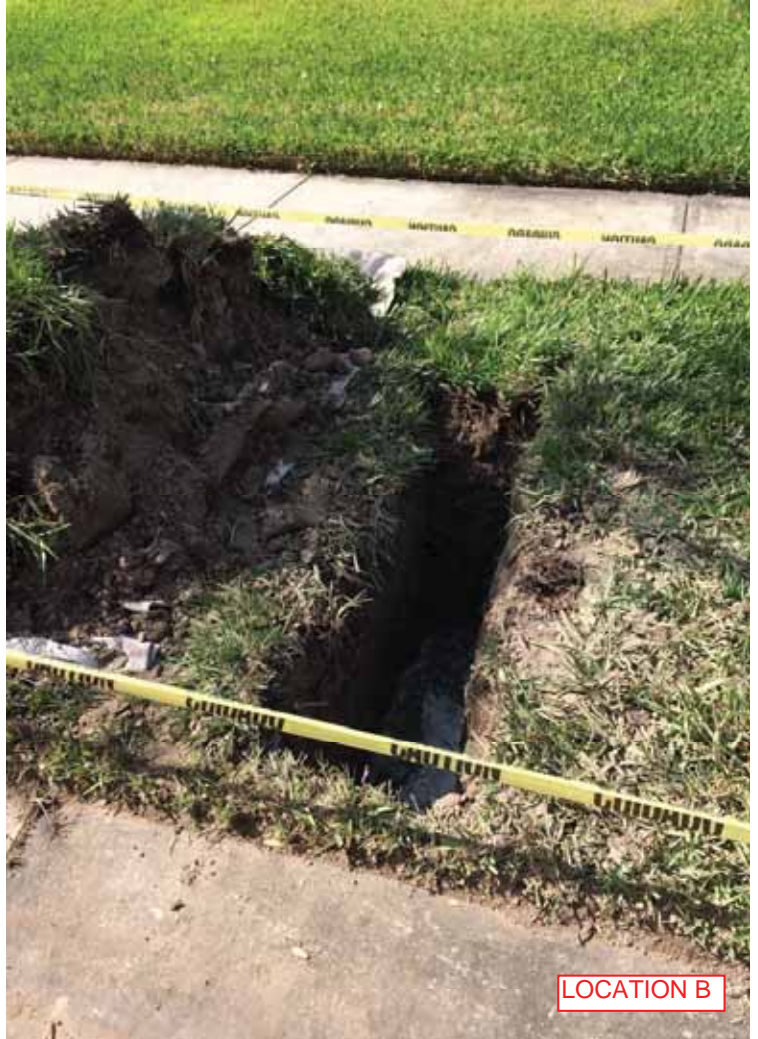
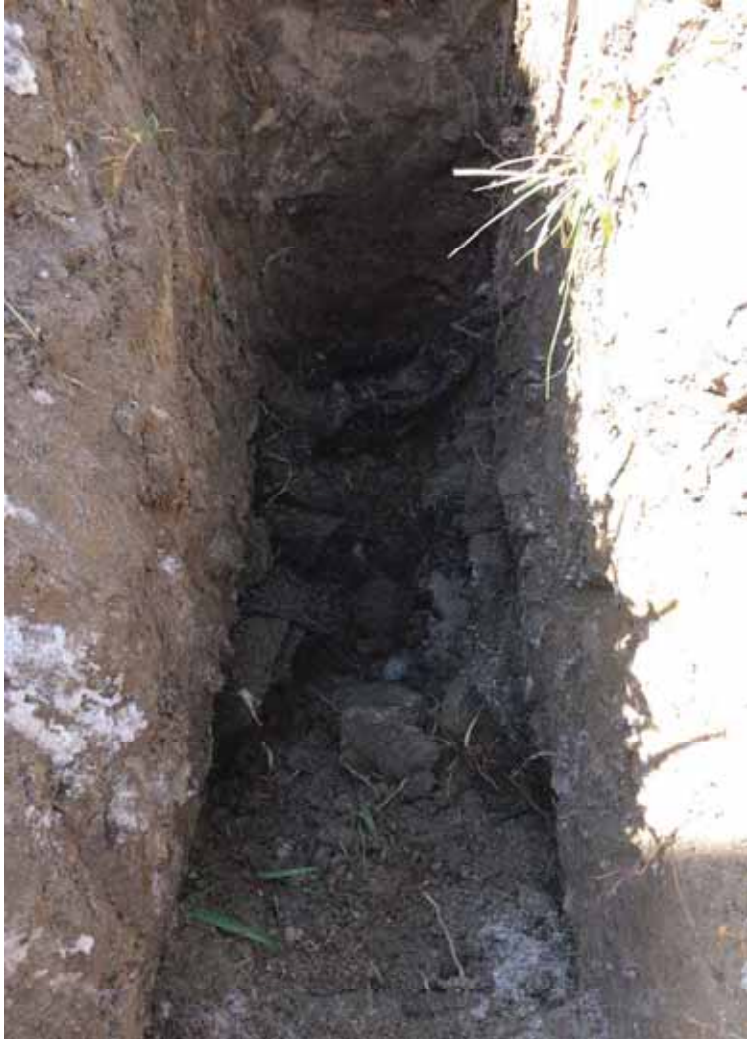
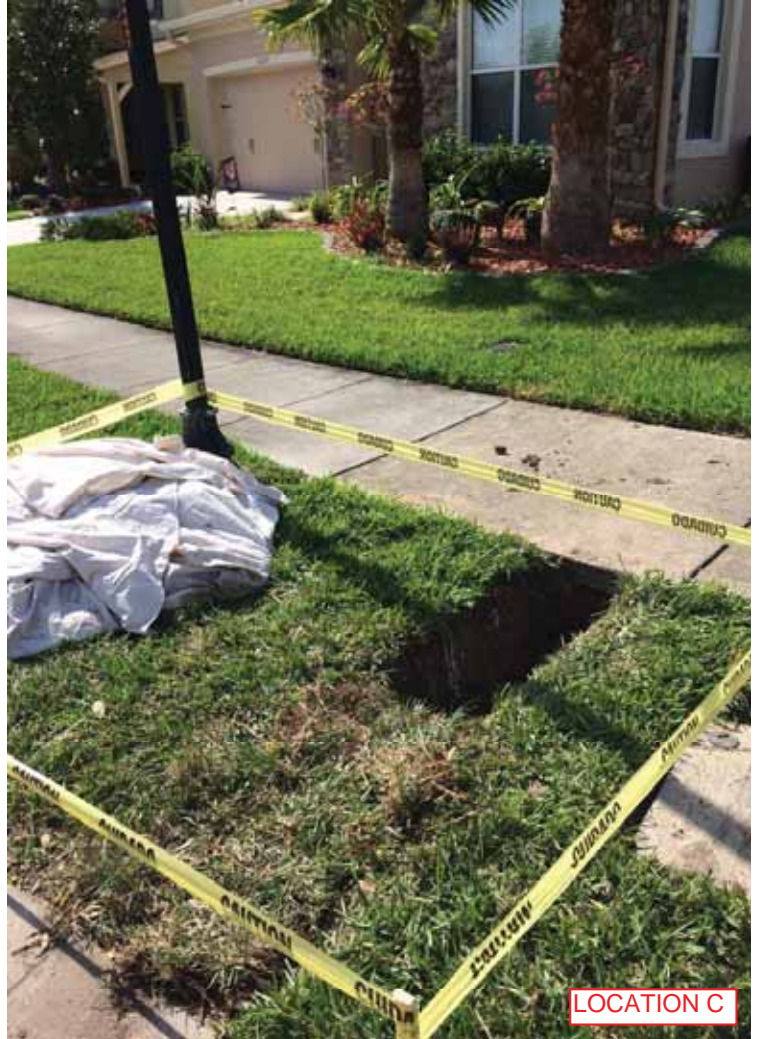
Based on the findings from the underdrain camera scope investigation, Spearem Enterprises, LLC was contracted to performed underdrain cleanout services with a flexible auger (aka snake/roto-rooter) on both sides of Cottage Glen Lane. Debris and roots were cleared from both sides in addition to the obstruction on the northeast side. Photos taking during cleanout installation and underdrain cleanout are included in Appendix F.

Recently cleared underdrains should result in improved overall drainage along Cottage Glen Lane. If the seepage issue was due to blockages in the underdrain conduit Johnson Engineering anticipates a resolution to the seepage issue in this area.

Johnson Engineering recommends that the general seepage issues along Cottage Glen Lane be monitored by residents and staff observations during the rainy season of 2017. Should seepage issues continue to arise Johnson Engineering recommends soil borings be performed across a transect of Garden Alcove Loop and Cottage Glen Lane to identify changes in soil that could cause impediment in groundwater flow.
