WATERGRASS CDD I
SUMMARY REPORT: ASPHALT SEEPAGE INVESTIGATION

May 14, 2017

I. Project Background

The purpose of this report is to present a summary of special services provided to Watergrass CDD to assist with the diagnosis of an asphalt seepage issue within the community. The scope of services included monitor well installation, survey, data collection and analysis, and in drain camera scope investigation.

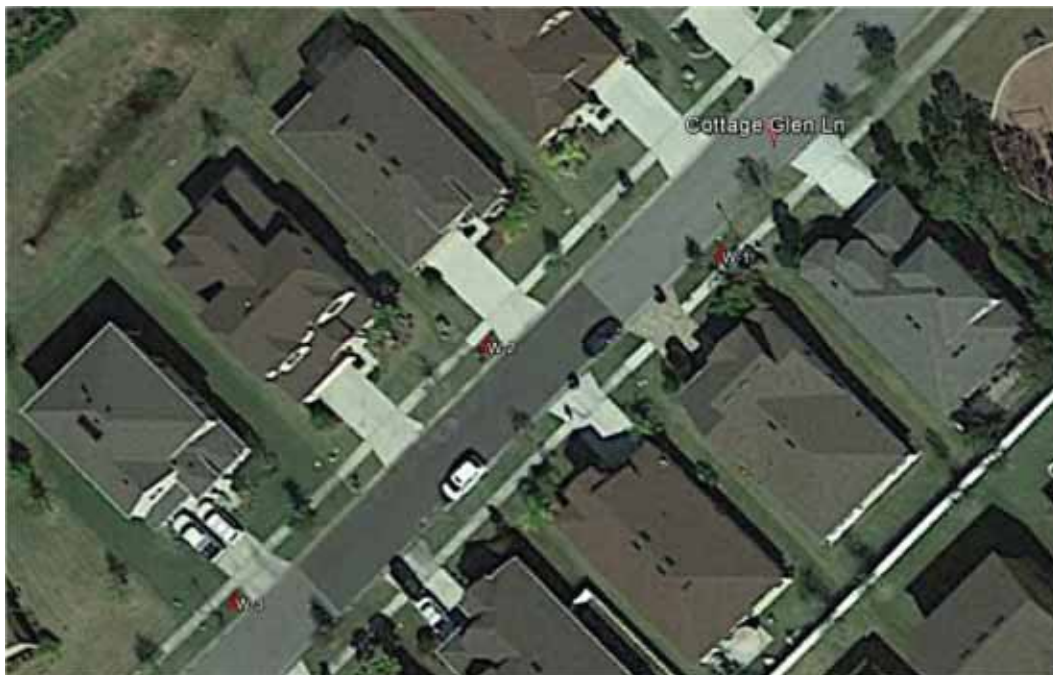
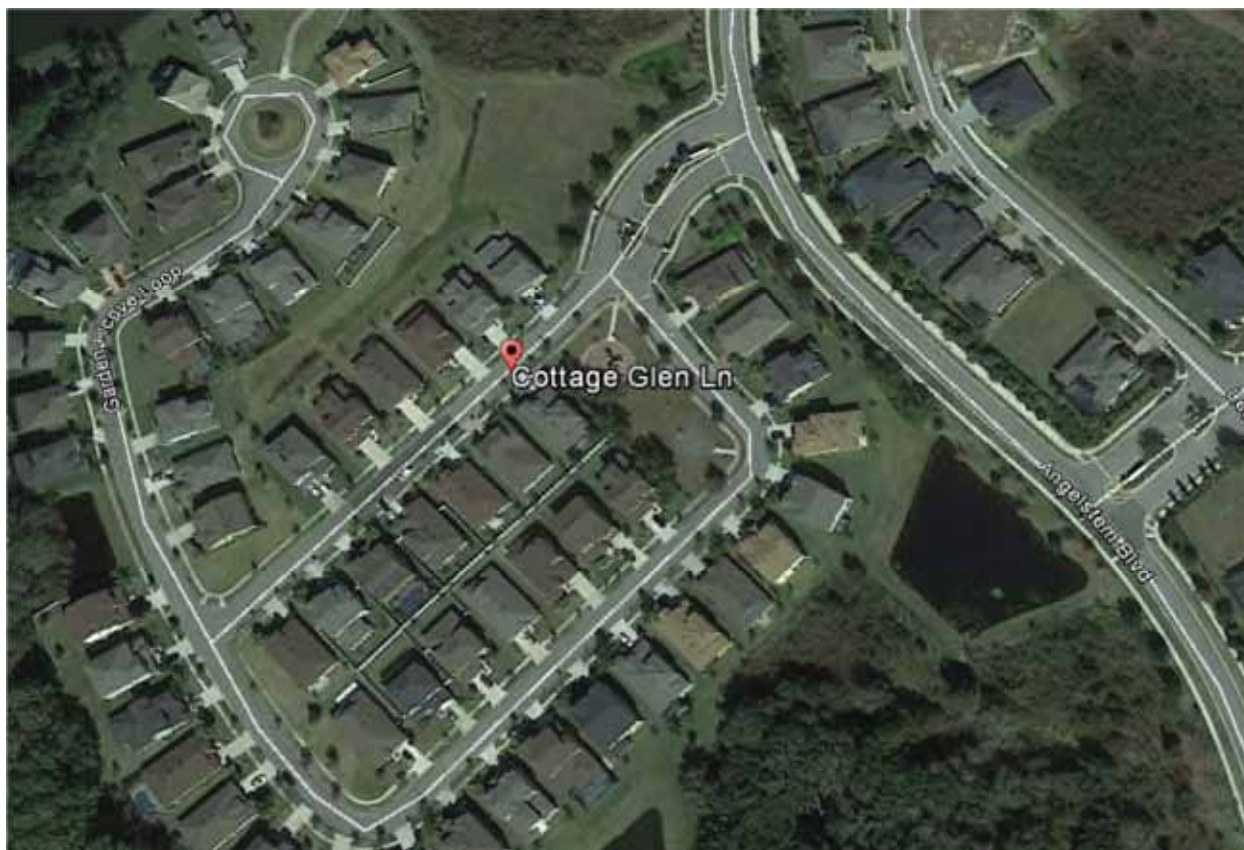
Wells were installed at the three locations directed on correspondence from your firm. Wells were installed November 11, 2016, and are scheduled for removal within 10 working days. The location of the wells is presented on the figures provided below:

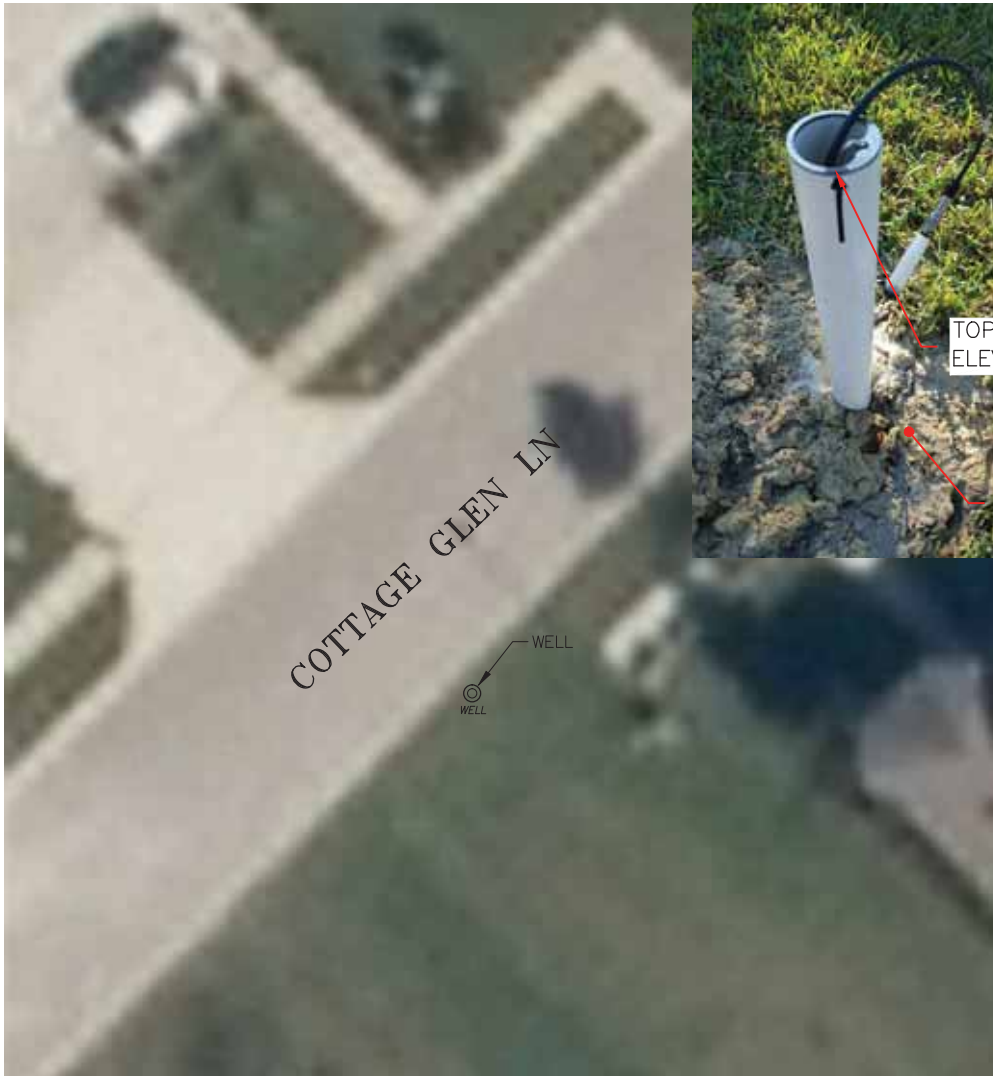
WELL #1 EXHIBIT
SECTION 35, TOWNSHIP 25 SOUTH, RANGE 20 EAST
PASCO COUNTY, FLORIDA

TOP OF WELL CASING
ELEV. = 103.61' (NAVD88)

NATURAL GROUND
ELEV. = 101.87' (NAVD88)

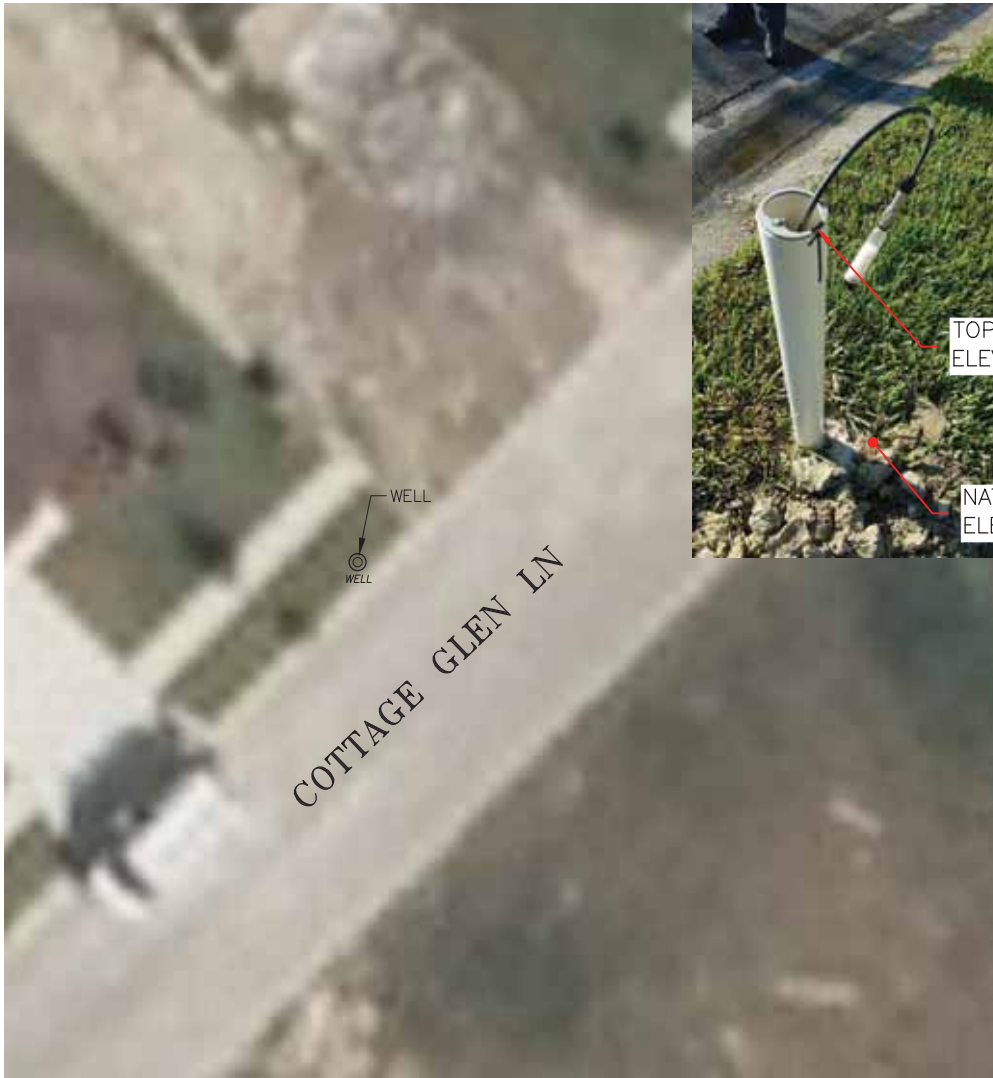
WELL #2 EXHIBIT

TOP OF WELL CASING
ELEV. = 102.69' (NAVD88)

NATURAL GROUND
ELEV. = 100.34' (NAVD88)

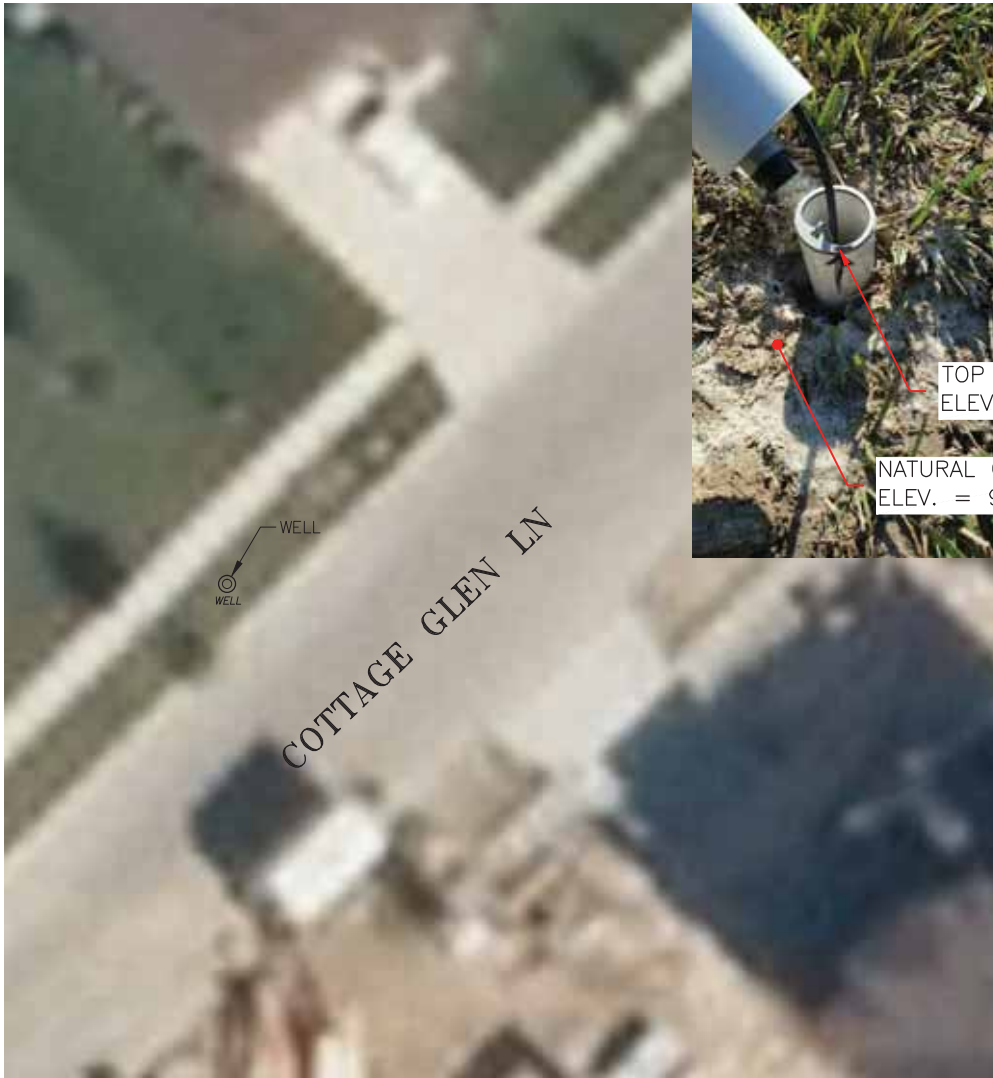
WELL #3 EXHIBIT
SECTION 35, TOWNSHIP 25 SOUTH, RANGE 20 EAST
PASCO COUNTY, FLORIDA

TOP OF WELL CASING
ELEV. = 98.90' (NAVD88)

NATURAL GROUND
ELEV. = 98.63' (NAVD88)

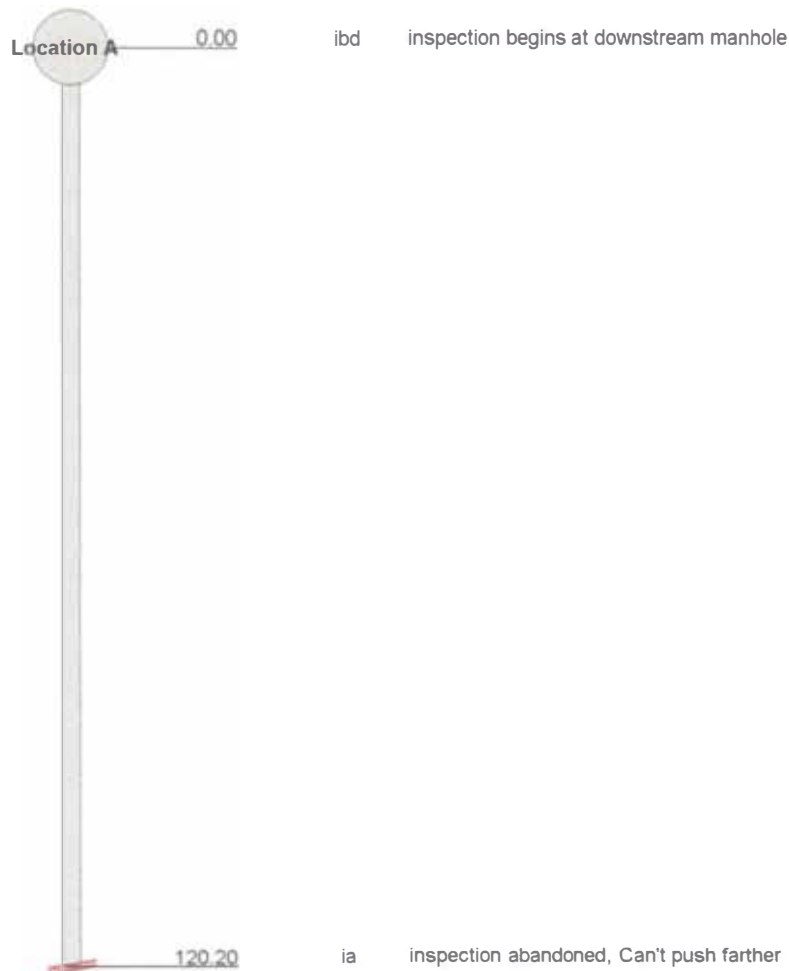
Reason of inspection :	Final Inspection	Pipe Size :	6 inch
Section type :	Storm Sewer	Pipe Material :	Plastic
